AN ECOLOGICAL AND INDUSTRIAL HERITAGE SURVEY OF THE MOUNTMELLICK CANAL

John Feehan and Fred Hamond

An action of the Laois Heritage Plan 2002-2006

for Laois County Council October 2006

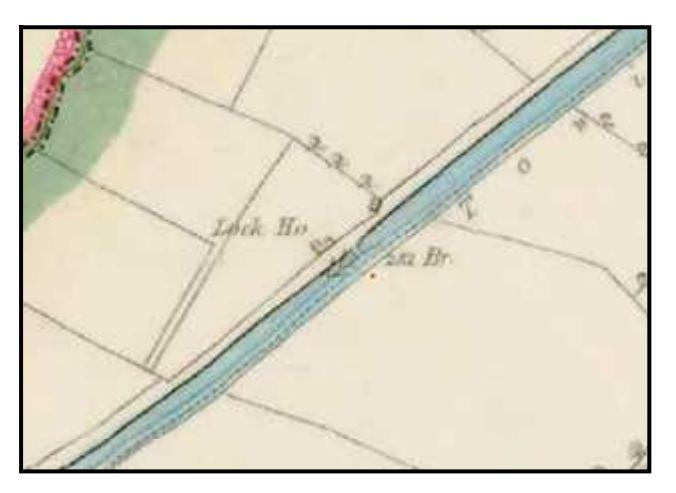
Fig 1.1 Lock 3 at Tinnakill, as depicted on 1839 OS six-inch map (rescaled to 1:2500). Note also the uncaptioned lock house and bridge at its north-east end.

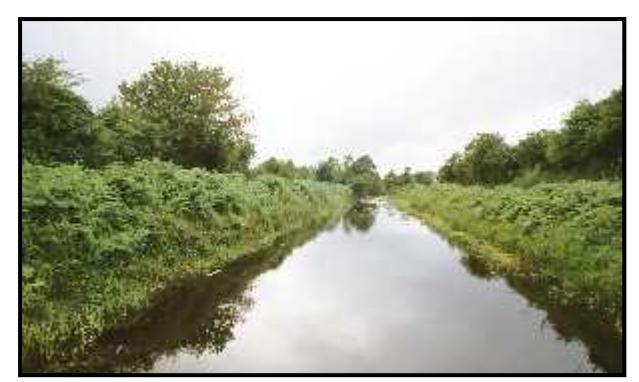
Fig 3.2a Reach 0 – open/watered section south of Coughlan's Bridge.

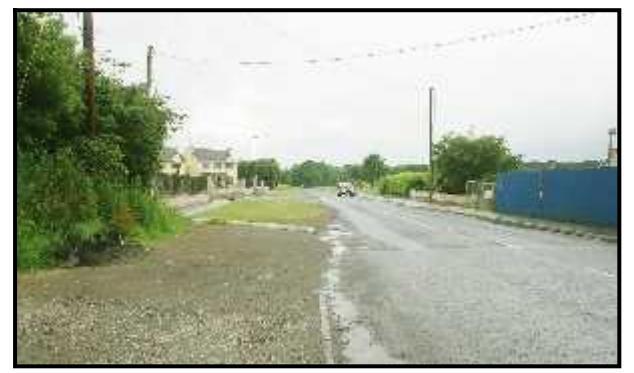
Fig 3.2c Reach 2 – Portarlington ring road, west of Odlum's Mill.

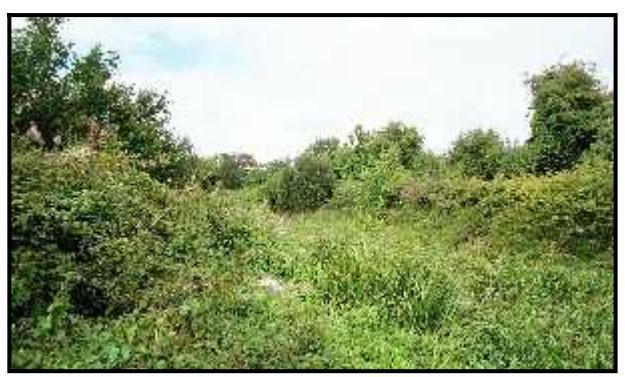
Fig 3.2b Reach 1 - open/dewatered section east of Poartarlington Lock.

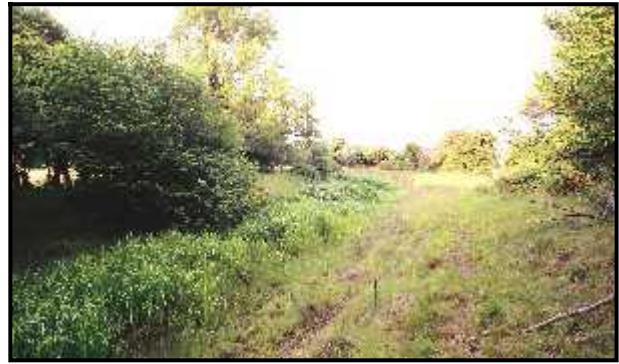
Fig 3.2d Reach 3: open/dewatered section east of Dangans Bridge.

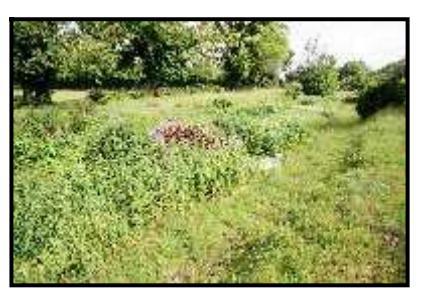
The privately owned sections of open canal, particularly those not permanently watered, are especially vulnerable to infilling. Fly tipping is particularly detrimental as it both degrades the canal's amenity value and encourages more dumping (fig 3.3).

Fig 3.3 Fly tipping near Dangans Bridge.

It is recommended that all open stretches of canal, and the above sections in particular, be considered for statutory protection by including them in the Records of Protected Structures for counties Laois and Kildare and/or the Record of Monuments & Places. This will ensure that the surviving sections of canal are embodied in the statutory planning process. Such a designation should, in theory, provide a mechanism for managing any development proposals along its line (including infilling).

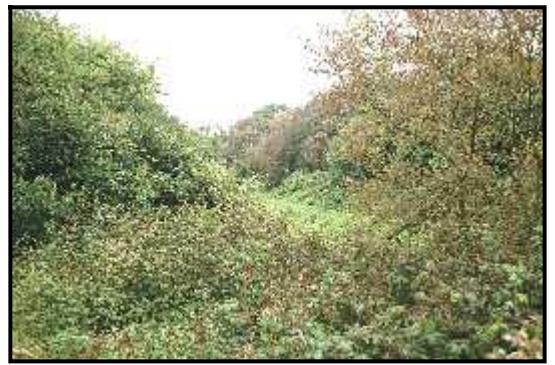
Fig 4.3 Looking north-east from south-west end of dewatered section 106.

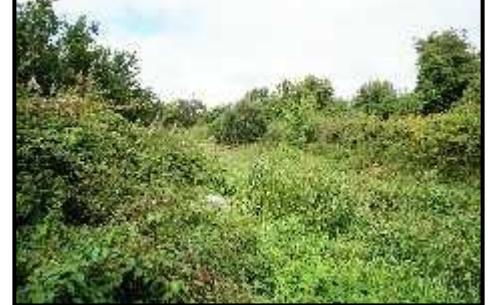
yellow flag etc (fig 4.6). The margins and banks are extensively overgrown (principally by grey willow, hazel, ash and hawthorn) and in very poor condition, and there is none of the hazel coppice or woodland ground flora seen further east towards Lea Castle. Sometimes the bank is just a strip of grassland of little interest (as it is between the canal and the barley field south of the Sewage Plant). This strip is a continuation of the lane that runs beside the canal on the north side from Lock Bridge; for the length of the lane the boundary between it and the canal is a maintained hawthorn hedge.

Fig 4.6 West along section 118.

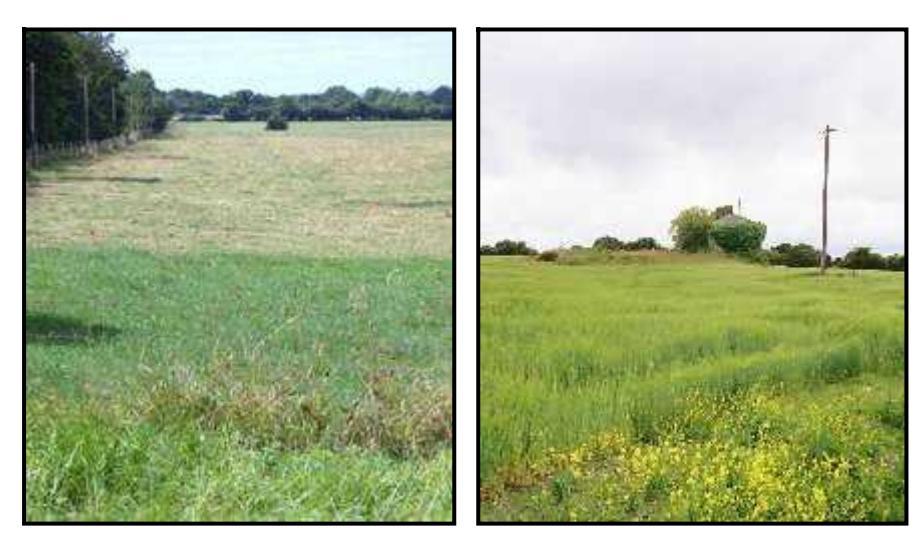
Fig 4.9 *Far left:* Looking south-west from Woodbrook Bridge in the direction of Tinnakill Lock. The canal ran down the field away from the camera but is now entirely infilled.

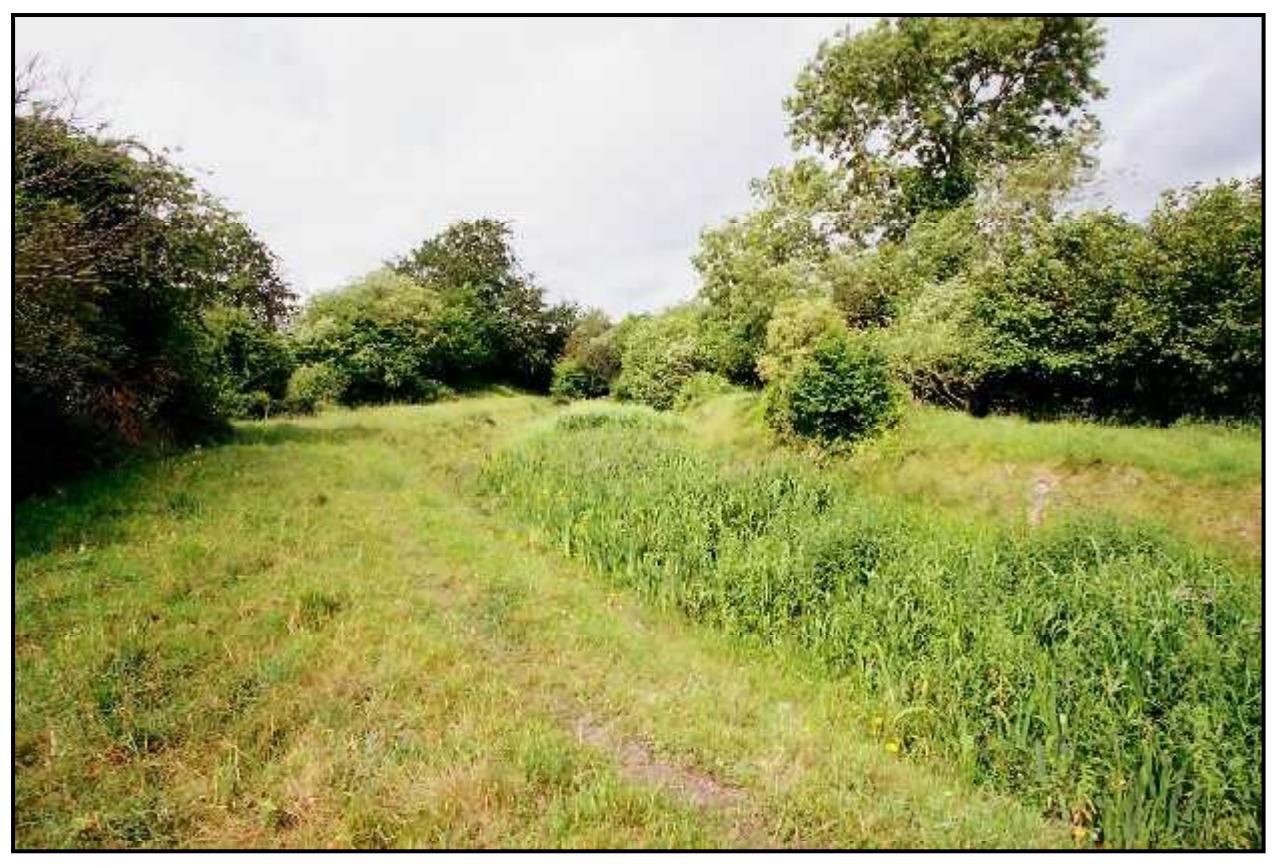
Fig 4.12 Looking south-west along S304, east of Dangans Bridge.

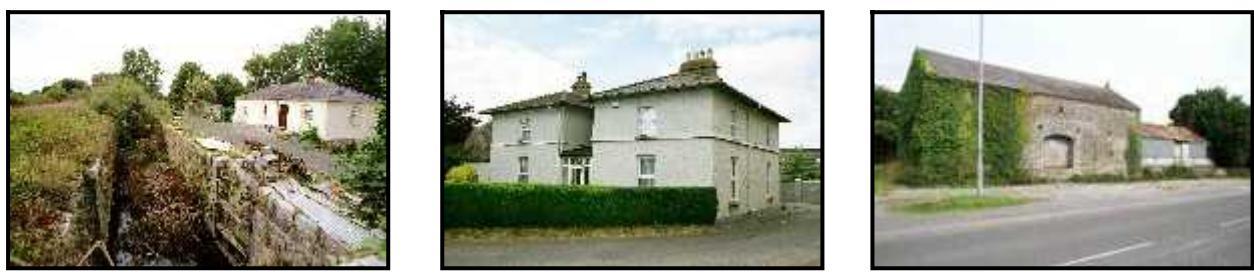
There is a well-maintained and occupied former canal agent's house at the Mountmellick terminus (fig 5.2b). An intact two-storey store survives at the quay adjoining Portarlington Lock (fig 5.2c). Only vestiges of the once-substantial stores at the terminus survive.

Fig 5.2a 1st lock and house. Fig 5.2b Canal agent's house, Mountmellick Fig 5.2c Store at 2nd lock.

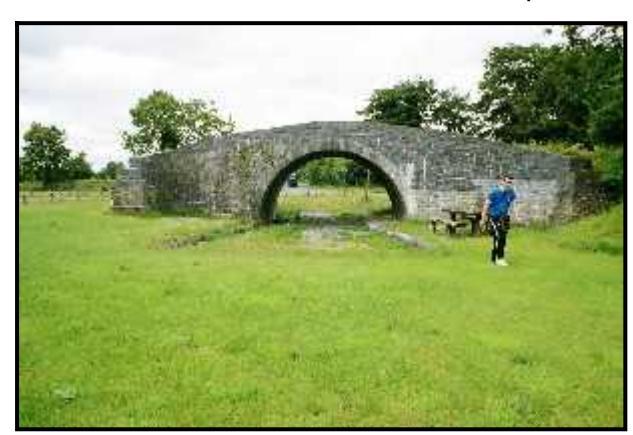
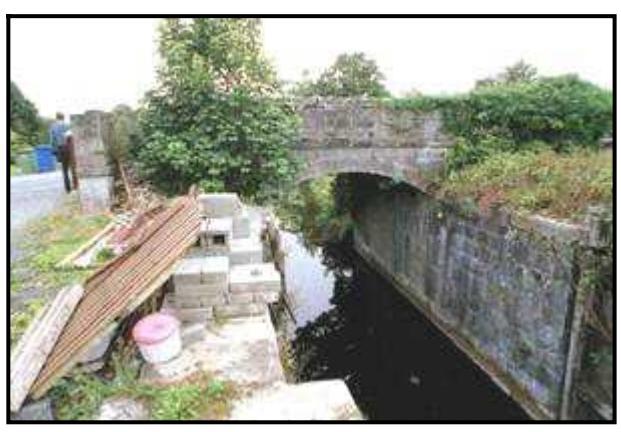
The exception this typical design is Coughlan's Bridge, which carries a public road across the south end of the 1st lock (fig 5.3b). Its abutments are a continuation of the sides of the lock chamber and are of regularly laid limestone blocks. The arch has a segmental profile instead of the usual half-circle and there is no towpath through the span.

Fig 5.3a Blackhall Bridge, Portarlington.

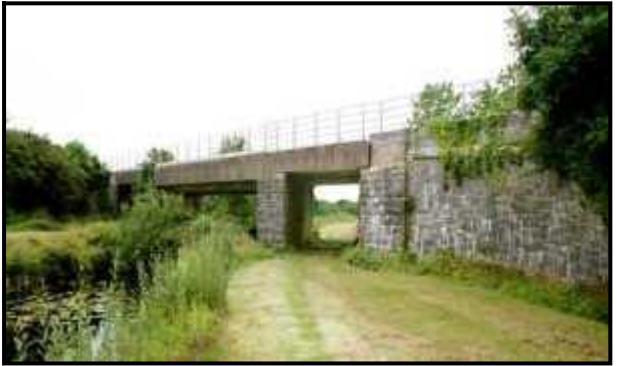
The canal is crossed in two places by railway bridges. The Monasterevin-Portlaoise line, opened in 1847, crosses Reach 0 as a skew triple girder span (fig 5.5a). The stone abutments and piers are original, but the actual spans are reinforced-concrete replacements of the originals.

Fig 5.5a Railway bridge west of Monasterevin.

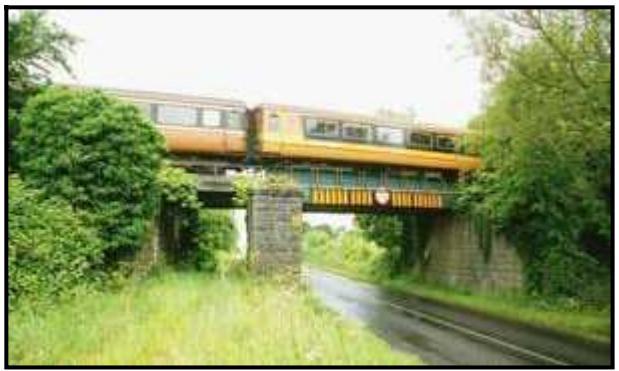
South-west of Portarlington, the Portarlington-Tullamore line of 1854 crossed Reach 2 as a triple girder span (fig 5.5b). The stone abutments and piers date to 1854, when the line was opened, but the metal spans are later replacements. Because the canal has been infilled hereabouts, the only physical indication that this bridge originally spanned the canal are the towrope marks on one of the piers of the middle span.

Fig 5.5 Railway bridge over canal at Portarlington.

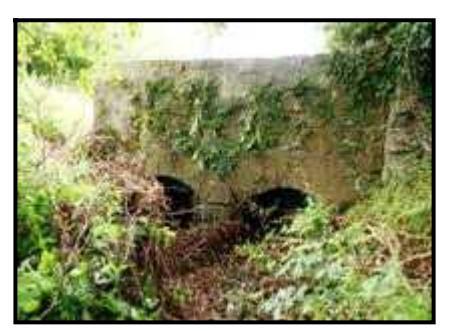
Fig 5.6 Culvert at Kilbride.

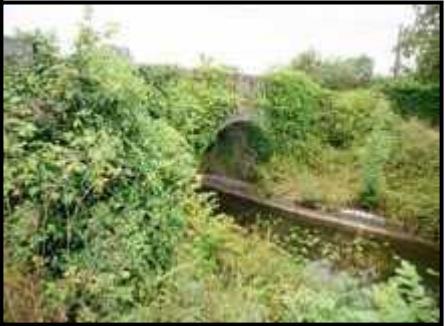
Those road bridges which are still in use are particularly vulnerable to replacement because of their relatively narrow widths and humped decks. Coughlan's Bridge (F101b), Wheelahan's Bridge (F103) and Bergin's Bridge (F105), all on the main Monasterevin-Portarlington road, are especially susceptible to replacement as they all have dogleg approaches and carry high volumes of fast-moving traffic. Although Dunne's Bridge (F002) is on a less busy road, it is likewise vulnerable because of its narrowness (fig 5.7).

Fig 5.7 Dunne's Bridge.

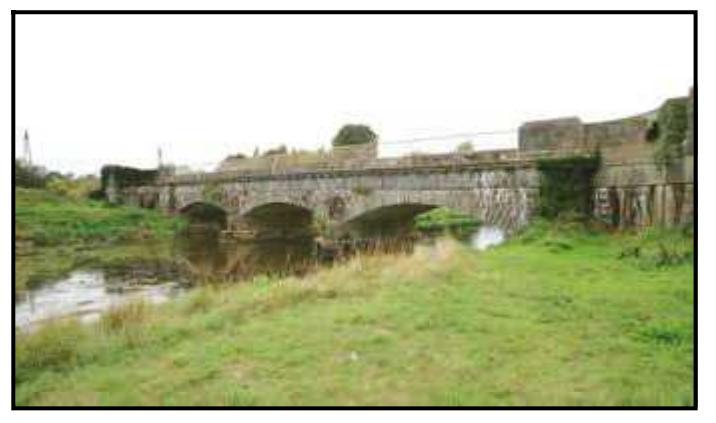
Fig 6.4 Barrow Aqueduct.

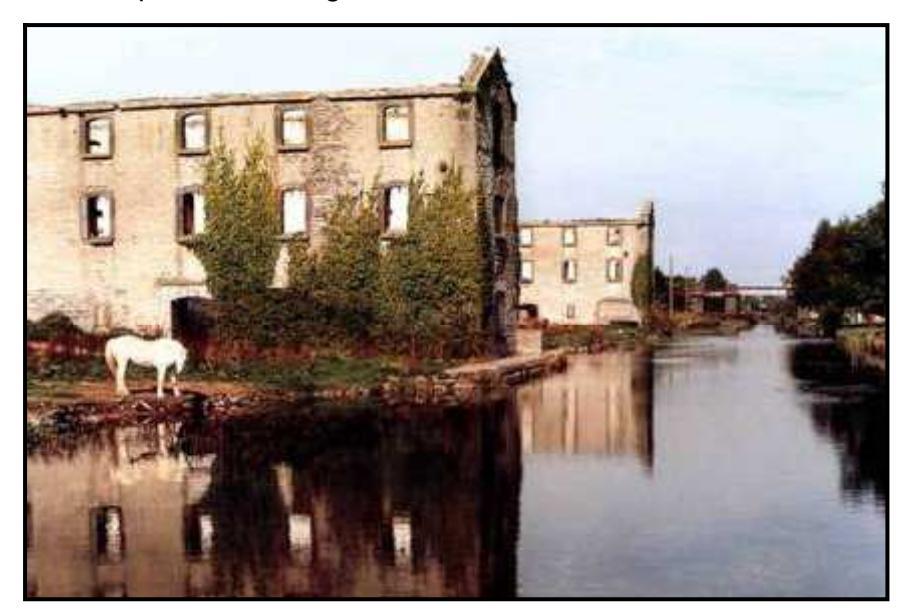
The extensive quay along the west side of the canal just above the draw bridge at Monasterevin originally had a warehouse at either end (fig 6.6). These were demolished when the area was redeveloped for housing.

Fig 6.6 Warehouses at Monasterevin Quay (now demolished). After Kevin Dwyer (2000), *Ireland the Inner Island: A Journey through Ireland's Waterways*, p.48 (Cork: Collins Press).
